# Project „SOPHIA“ - Final Report

(Study of Propeller Icing Hazard in Mini-UAV Aviation)

Meteomatics GmbH, St. Gallen 2017-05-01

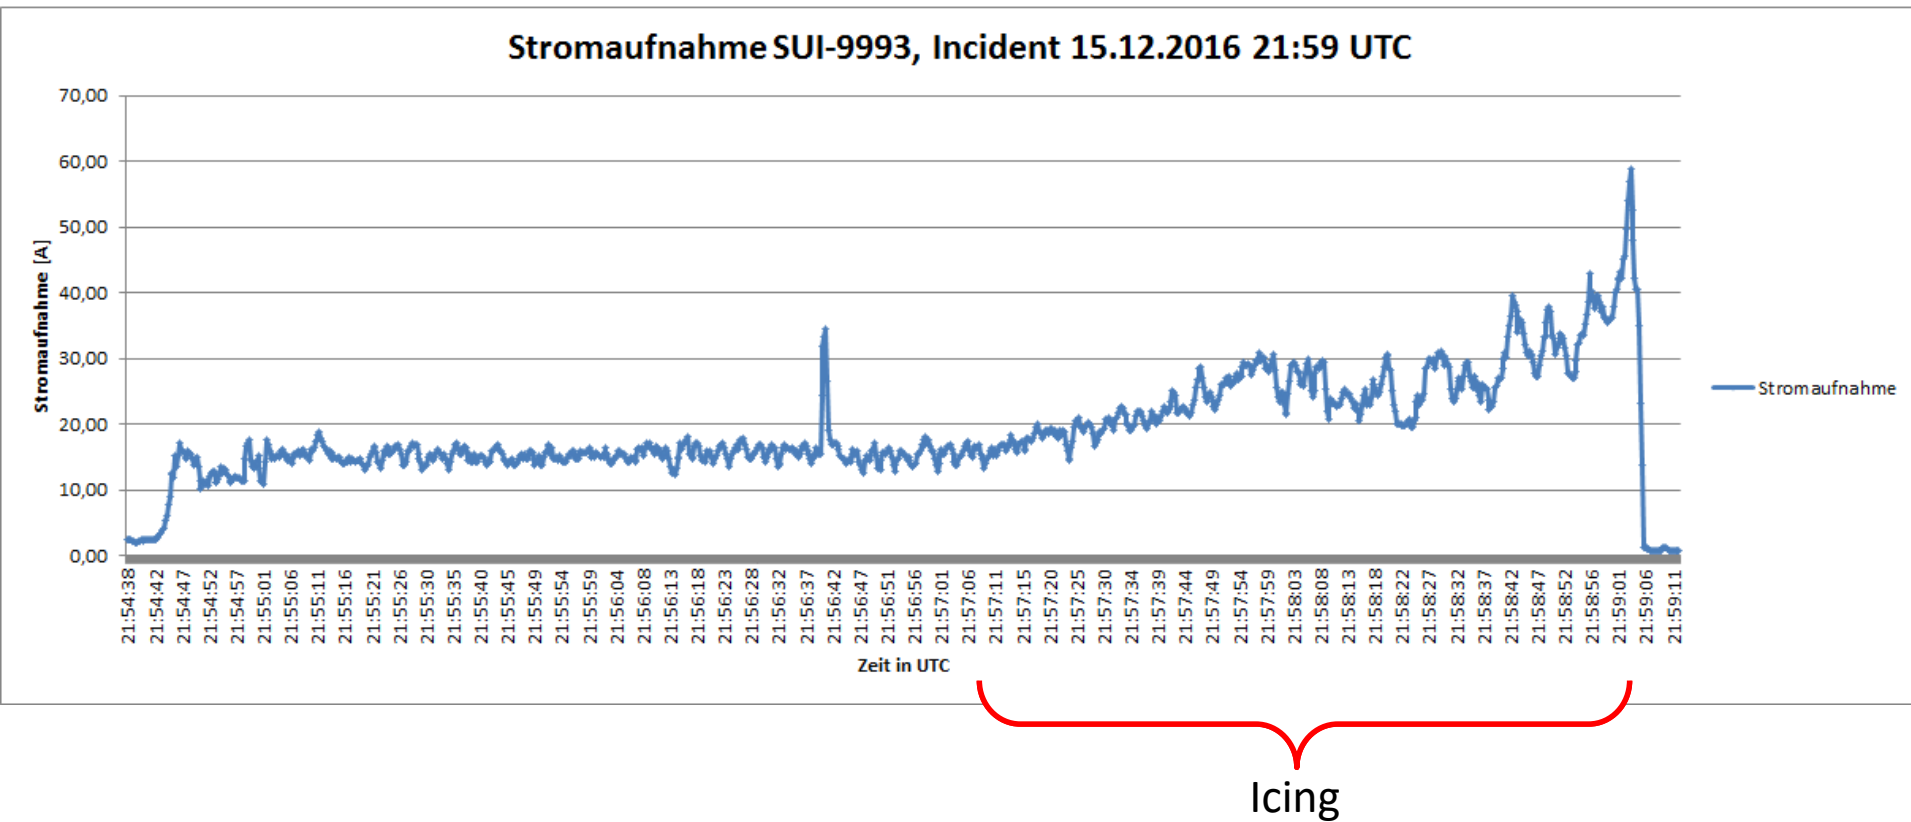
- Influence of Icing on power input  
→ Power input increases during Icing.

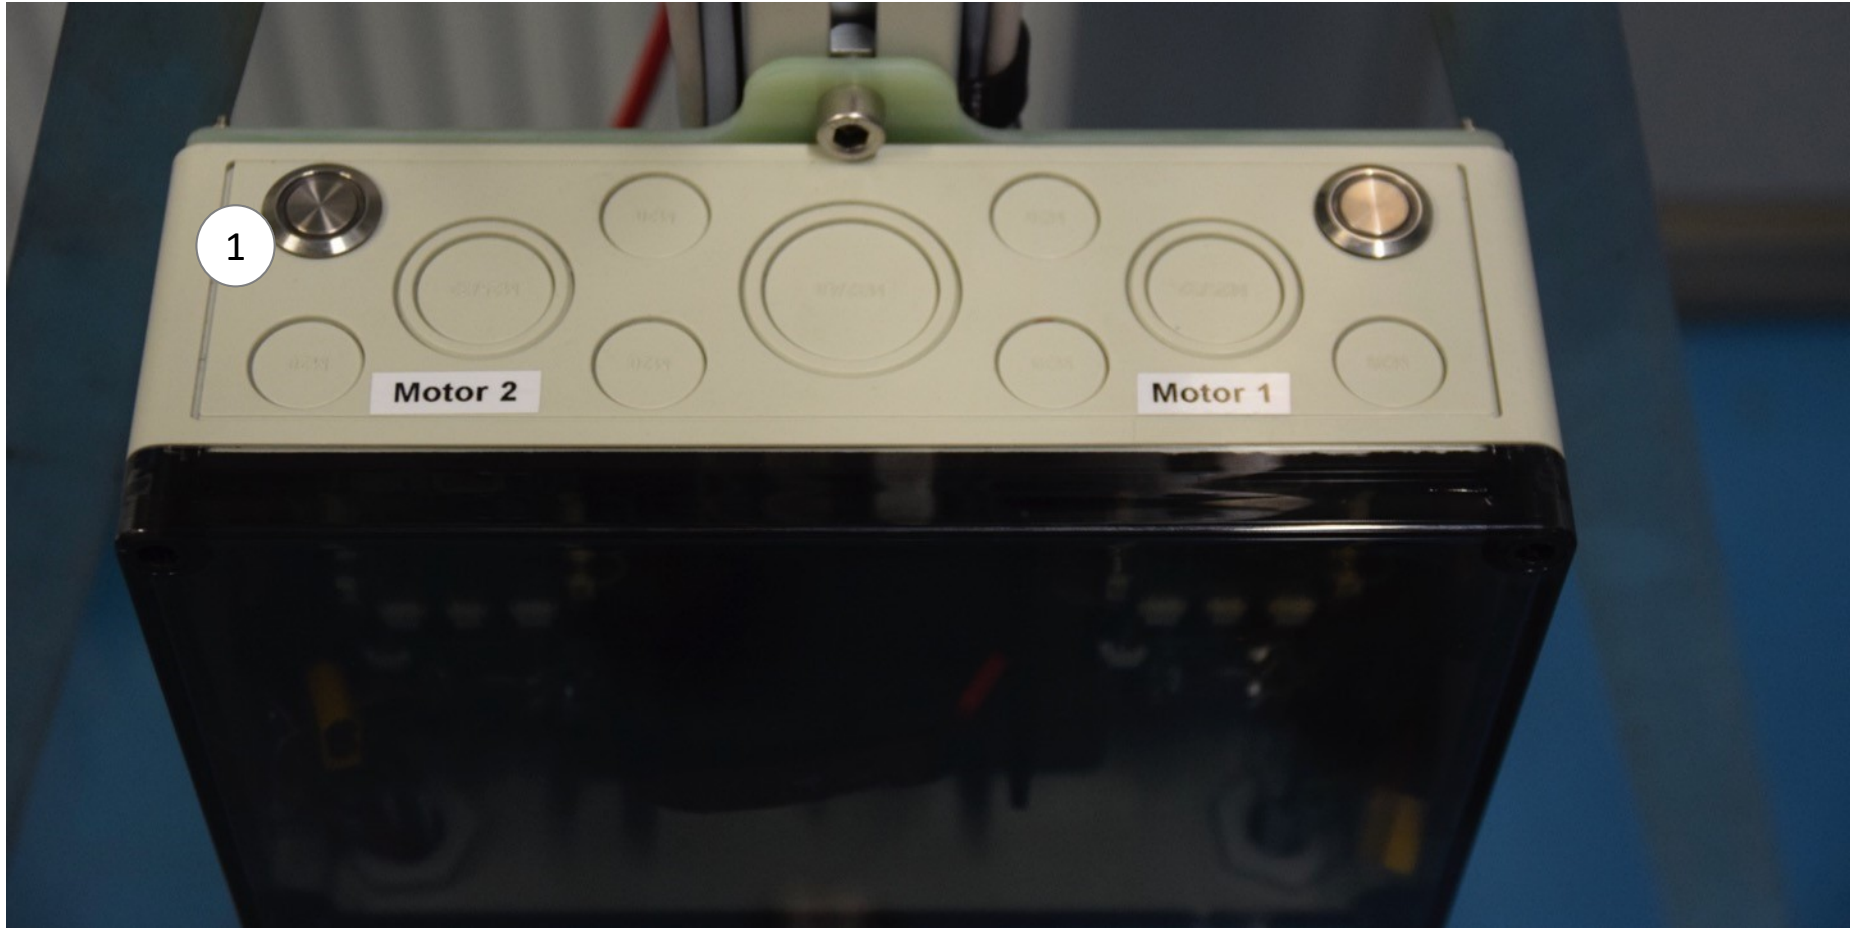
1: control button to pause/restart motor

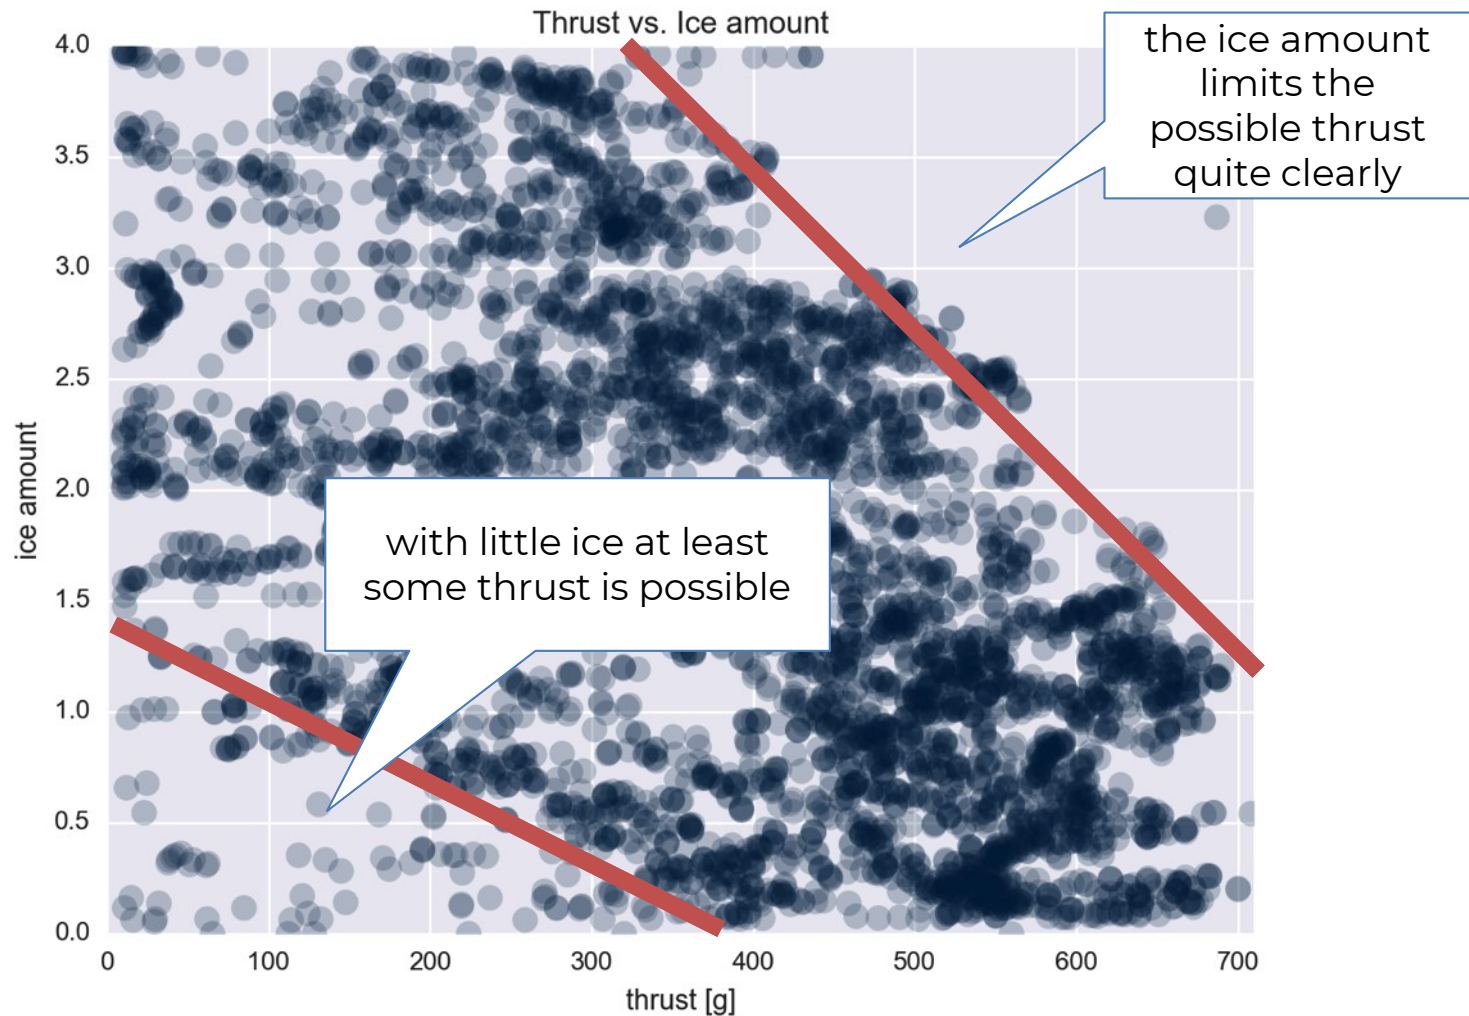
# Negative correlation between ice amount and thrust

- Ice amount was taken from the photographs (see example photographs in the appendix)
  - 0: no ice
  - 1: merely visible ice
  - 2: few ice (less than 2mm)
  - 3: much ice (less than 4mm)
  - 4: extreme ice
- Photographs only available when motor was stopped
  - Quite inaccurate values between the photographs (interpolation)
- **Weak negative correlation found between ice amount and thrust**
  - more ice means less thrust
  - **a certain ice amount limits the possible thrust very clearly**
  - **with little ice at least medium thrust is still possible**
  - maybe clearer evidence if more, and more accurate ice amount data

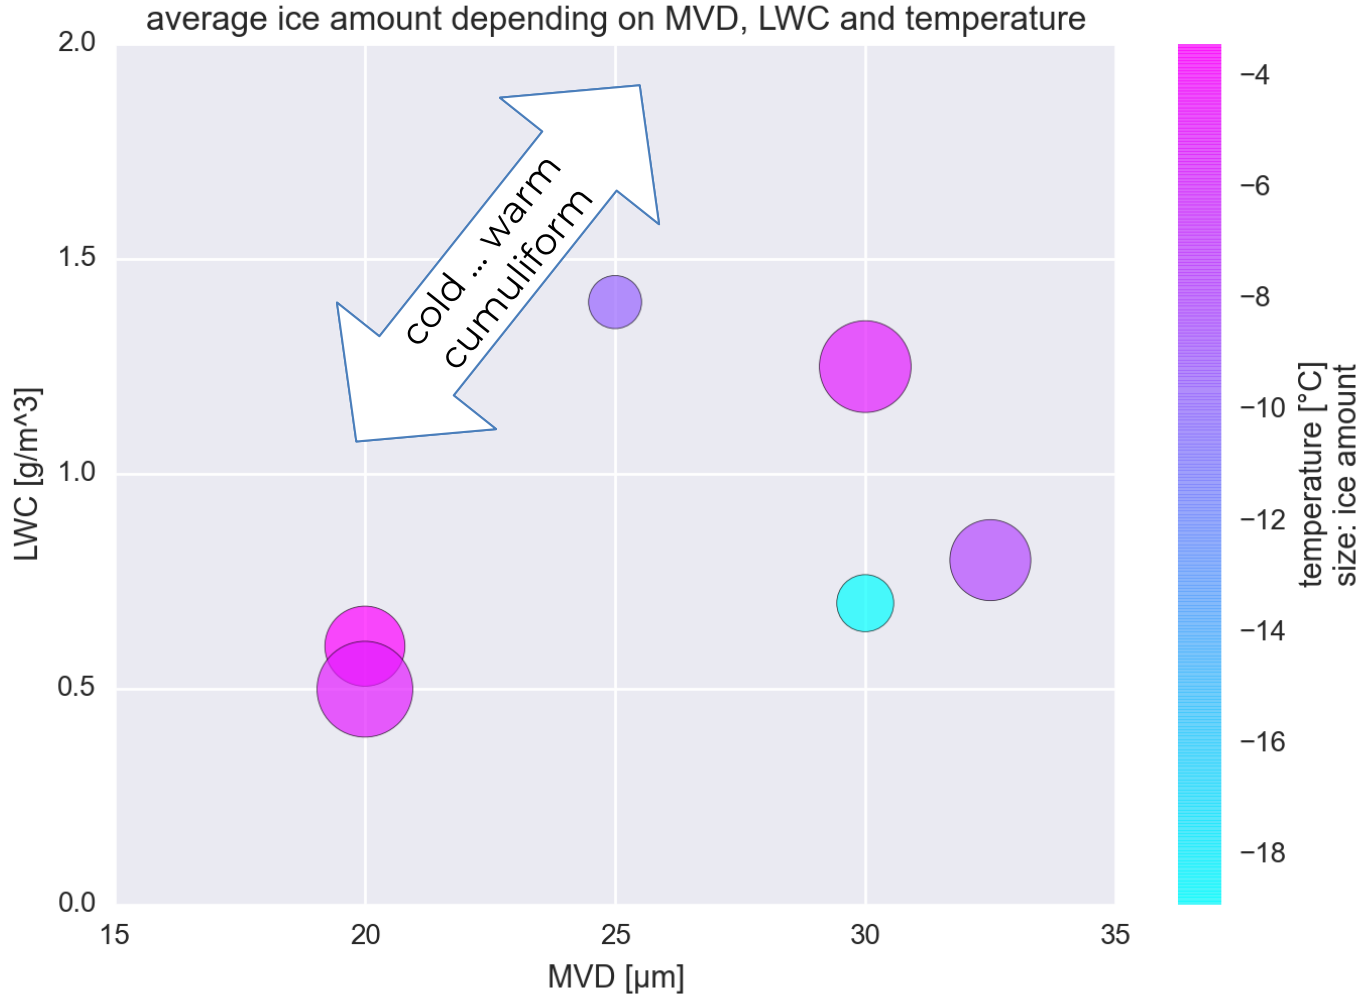
# In general more ice at higher temperatures

- The amount and speed of Icing depends on LWC, MVD and temperature
  - In general more ice at warmer temperatures
  - Faster Icing at high LDWC and warmer temperatures
- Combination of LWC and MVD: LDWC (Liquid Droplet Water Content)

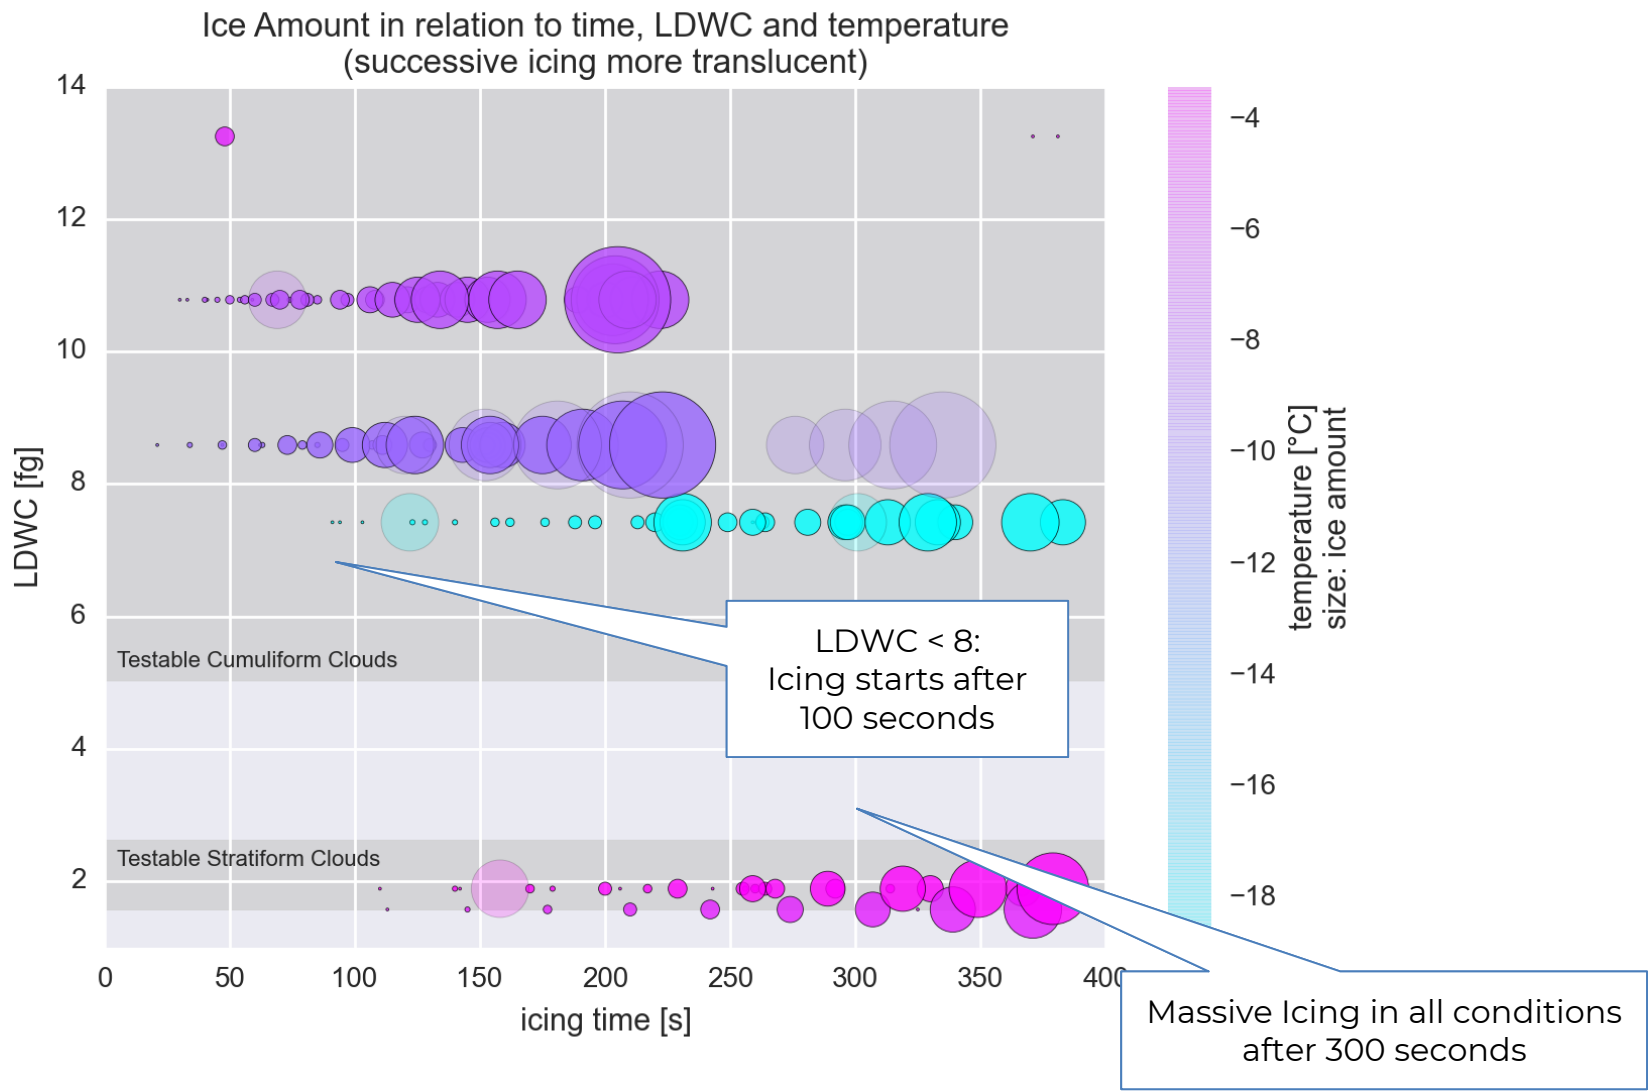
# Faster Icing at high LDWCs and warmer temperatures

- **LDWC < 8 fg (mostly stratiform cloud conditions):**
  - **About 100 seconds until Icing starts (1:40 minutes)**
- **All conditions:**
  - **massive Icing not later than 300 seconds (5 minutes)**

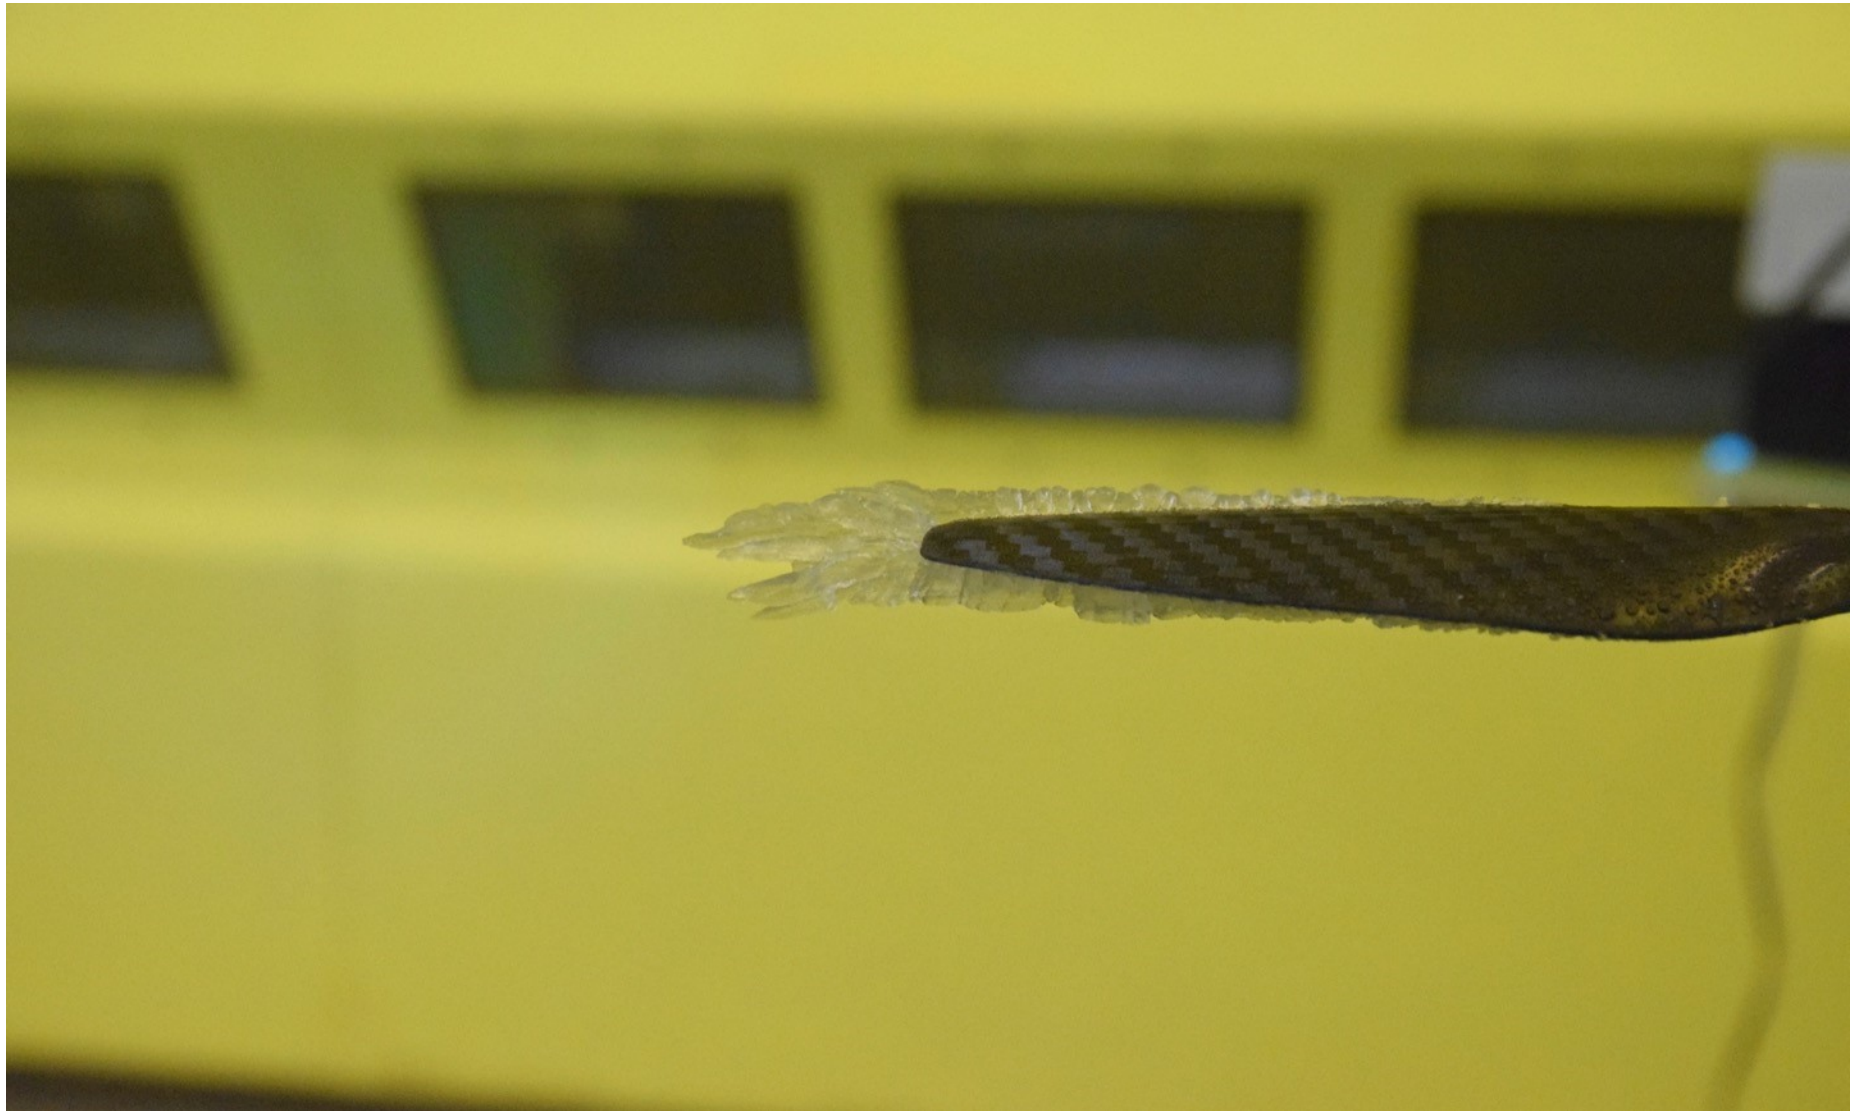
Clear ice ( $-2^{\circ}\text{C}$ ,  $\text{MVD}=20\mu\text{m}$ ,  $\text{LWC}=0.6\text{g}/\text{m}^3$ )

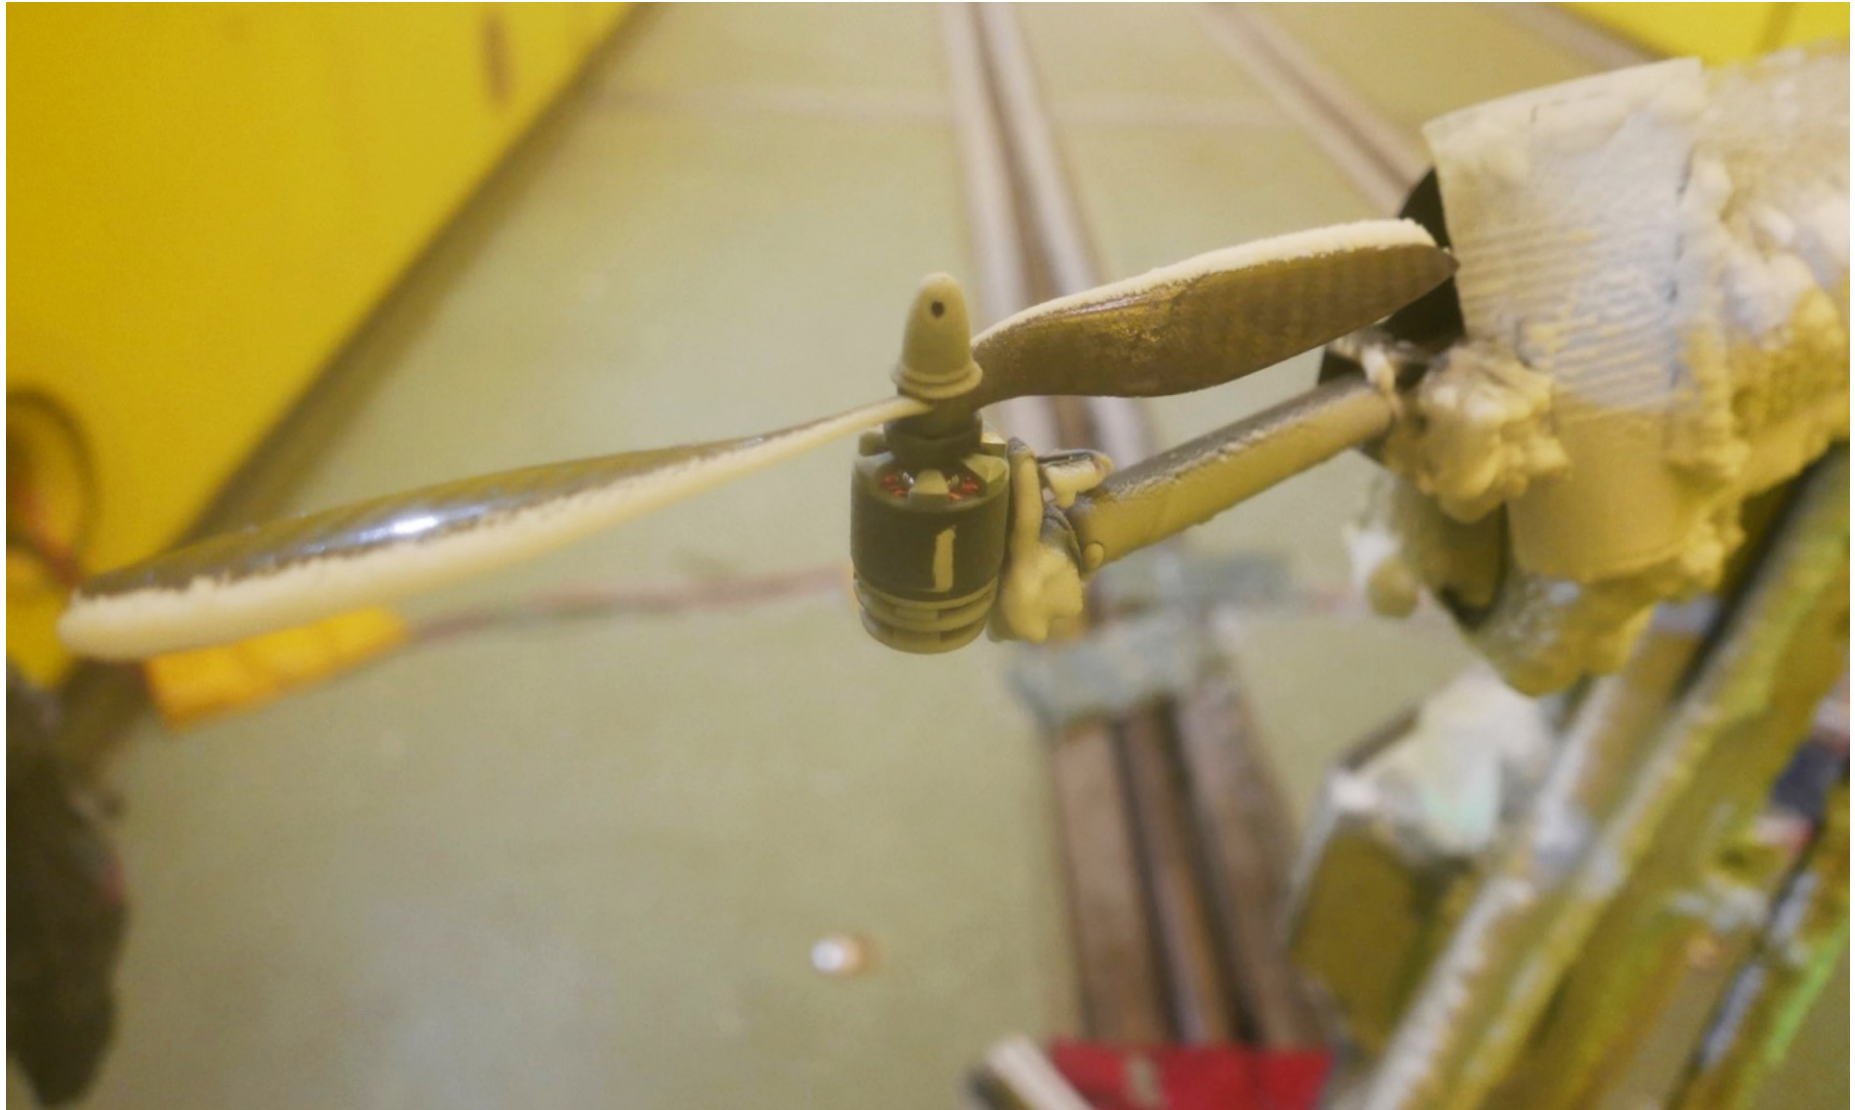
Hard rime (-20°C, MVD=30 $\mu$ m, LWC=0.7g/m<sup>3</sup>)

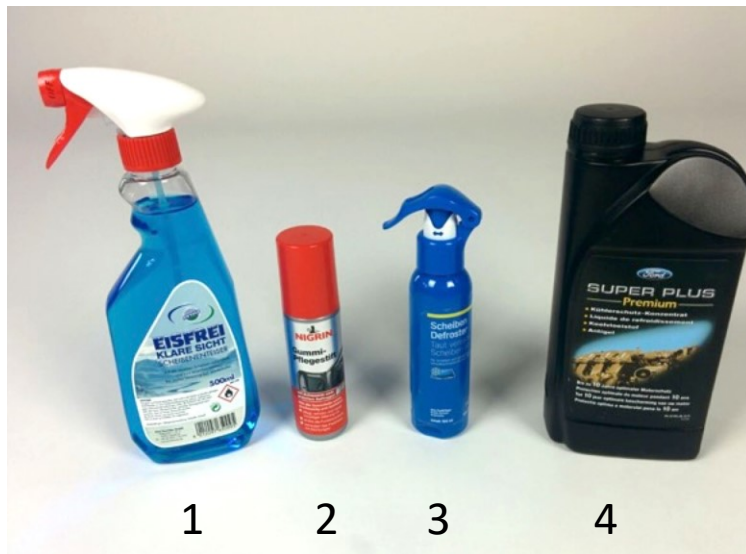
- Different de-Icing and Anti-Icing agents were tested
- None of these showed full protective effect
- **Effect depends on viscosity**
  - low viscosity: agents 1,3 slipped from the props very fast, no effect
  - higher viscosity: agents 2,4 had a delaying effect on the ice (maybe 1 or 2 minutes)
- **Not enough data to get clear evidence**

- 1: wind shield defroster (de-Icing)  
2: door rubber gasket protection (Anti-Icing)  
3: wind shield defroster (de-Acing)  
4: cooler protection concentrate (Anti-Icing)

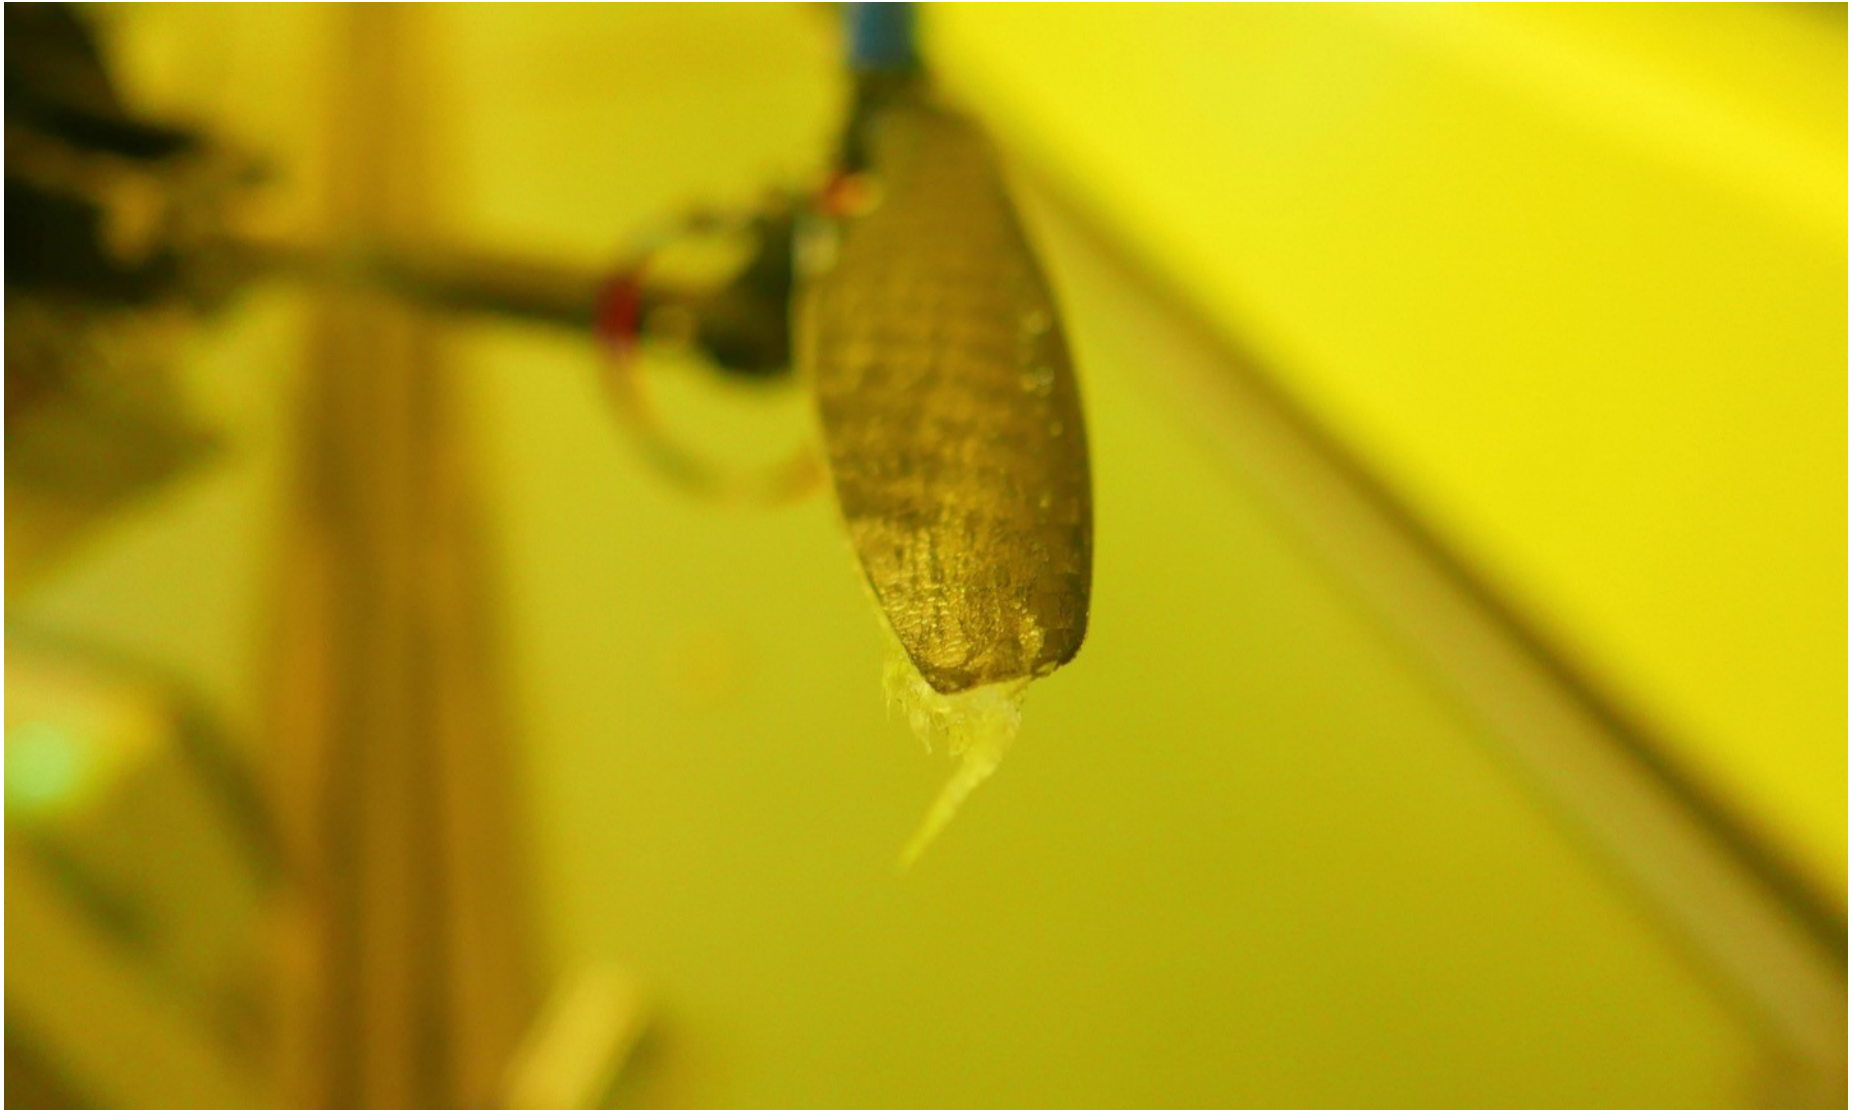
# Test 1, Motor 4 (little ice due to Anti-Icing agent #2)

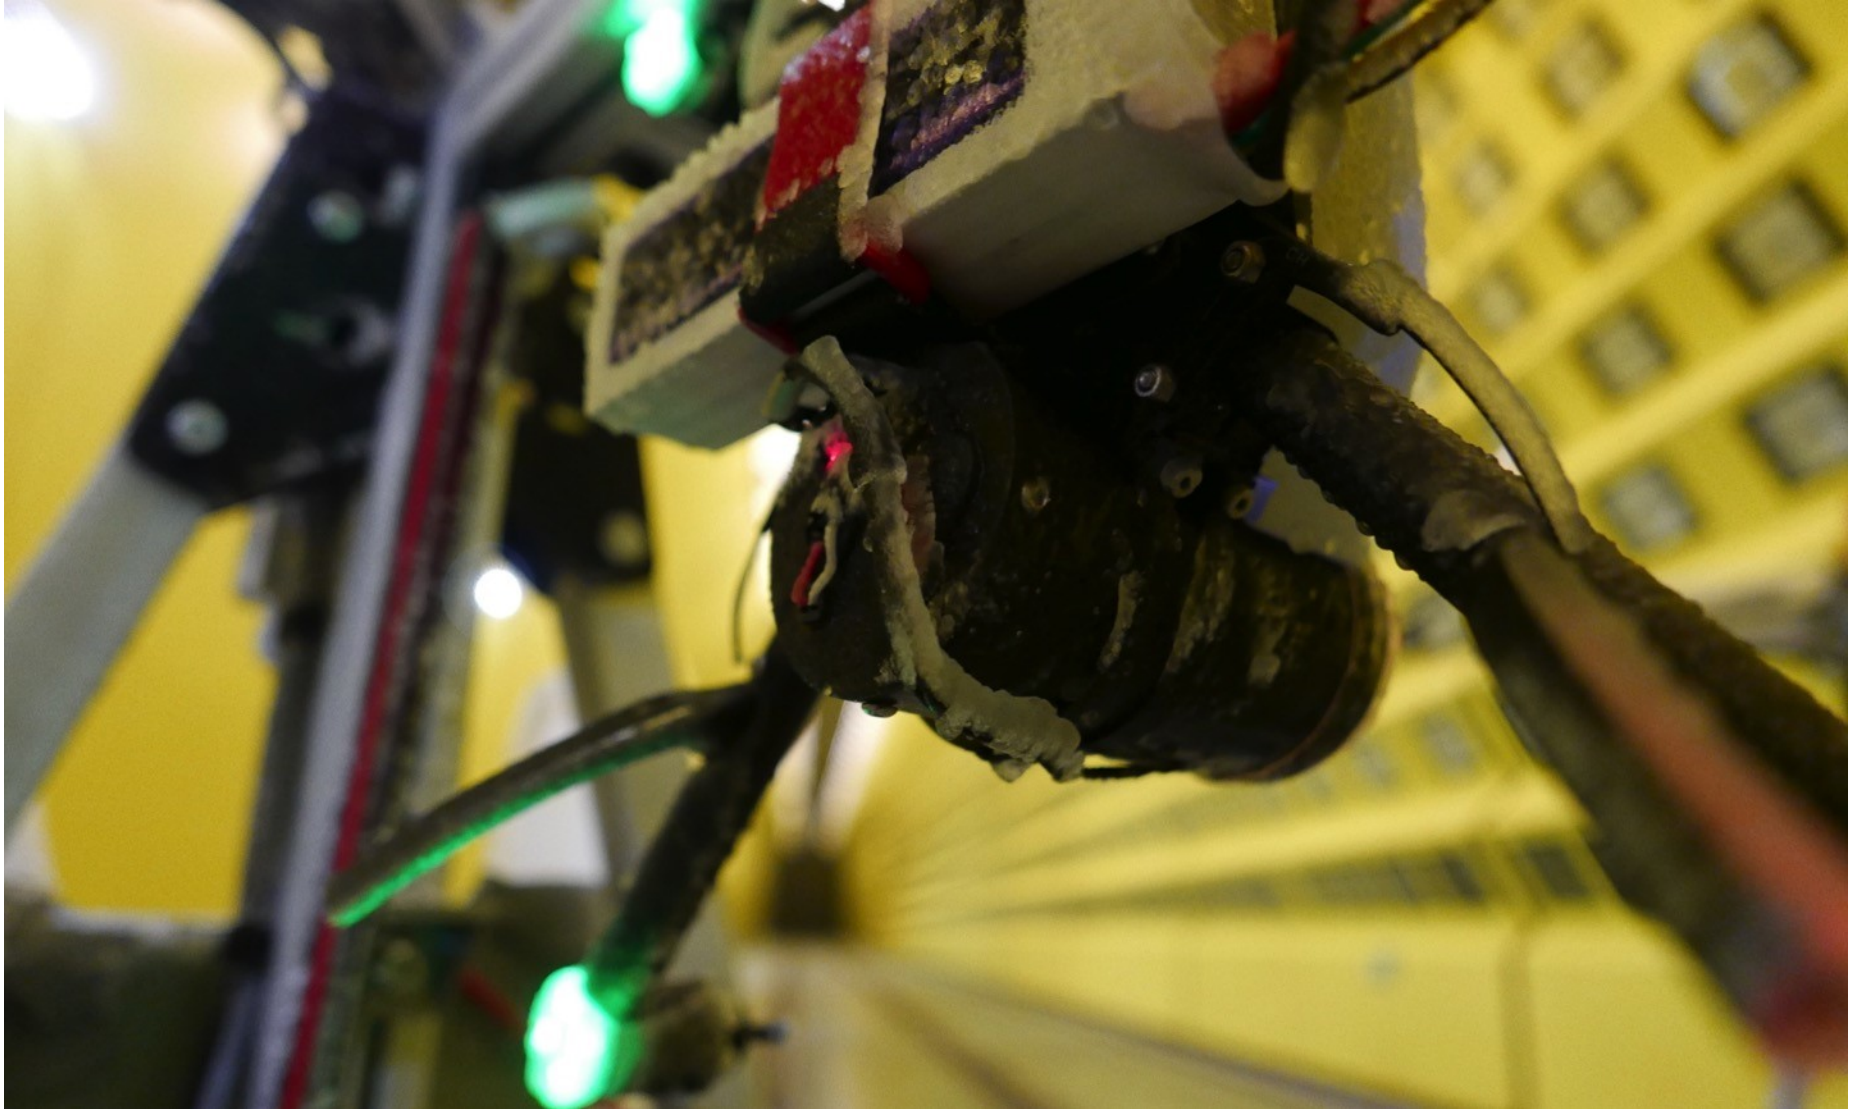
# Meteodrone body ice after 20 minutes

- During all tests one Meteodrone was placed in the test chamber
  - Energy supply connected, activated (position lights and heating on)
  - No propellers mounted
- The Icing on the body, the sensors and the parachute cap was documented
- Results
  - The electronics worked all the time (6 hours at up to  $-20^{\circ}\text{C}$ )
  - The sensors stayed ice-free at all times
  - The parachute cap iced at  $-20^{\circ}\text{C}$ 
    - possible voltage drop in the battery after over 6 hours

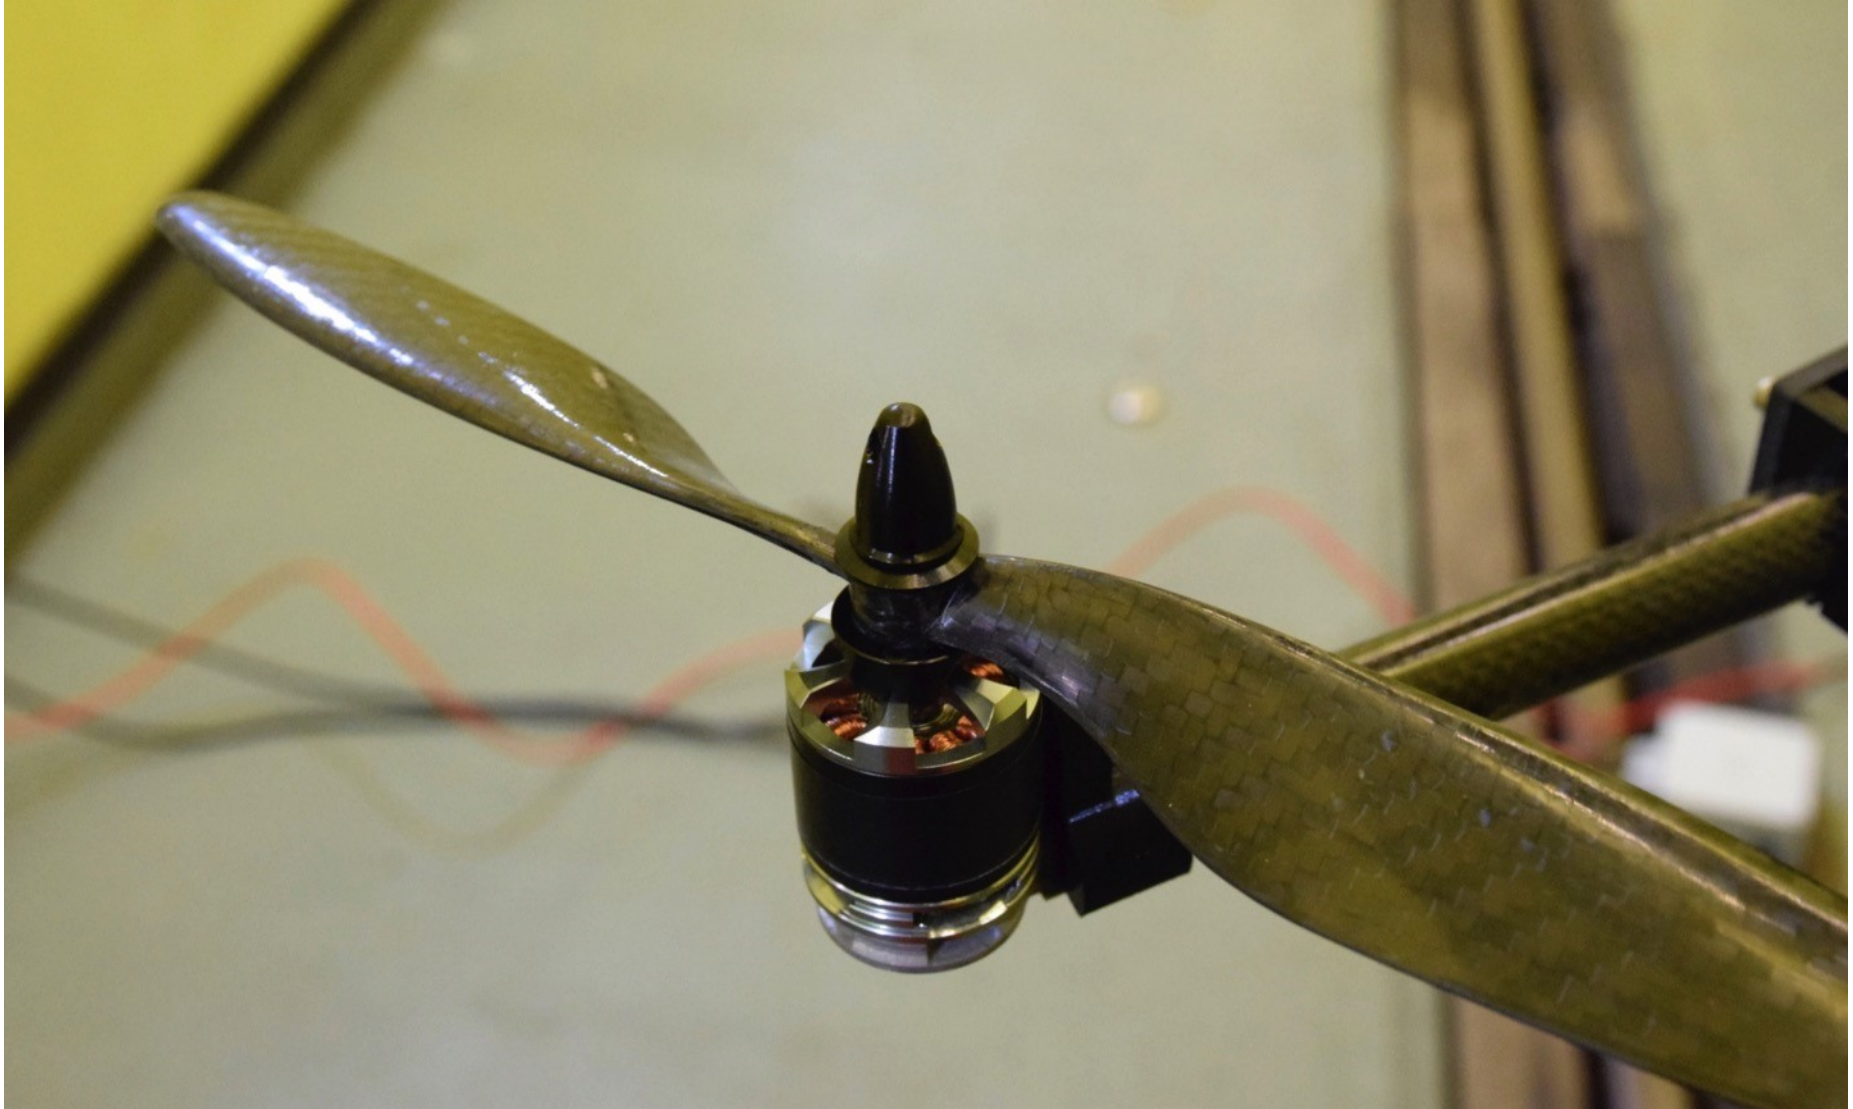
# Example Ice Amount 0 – No ice

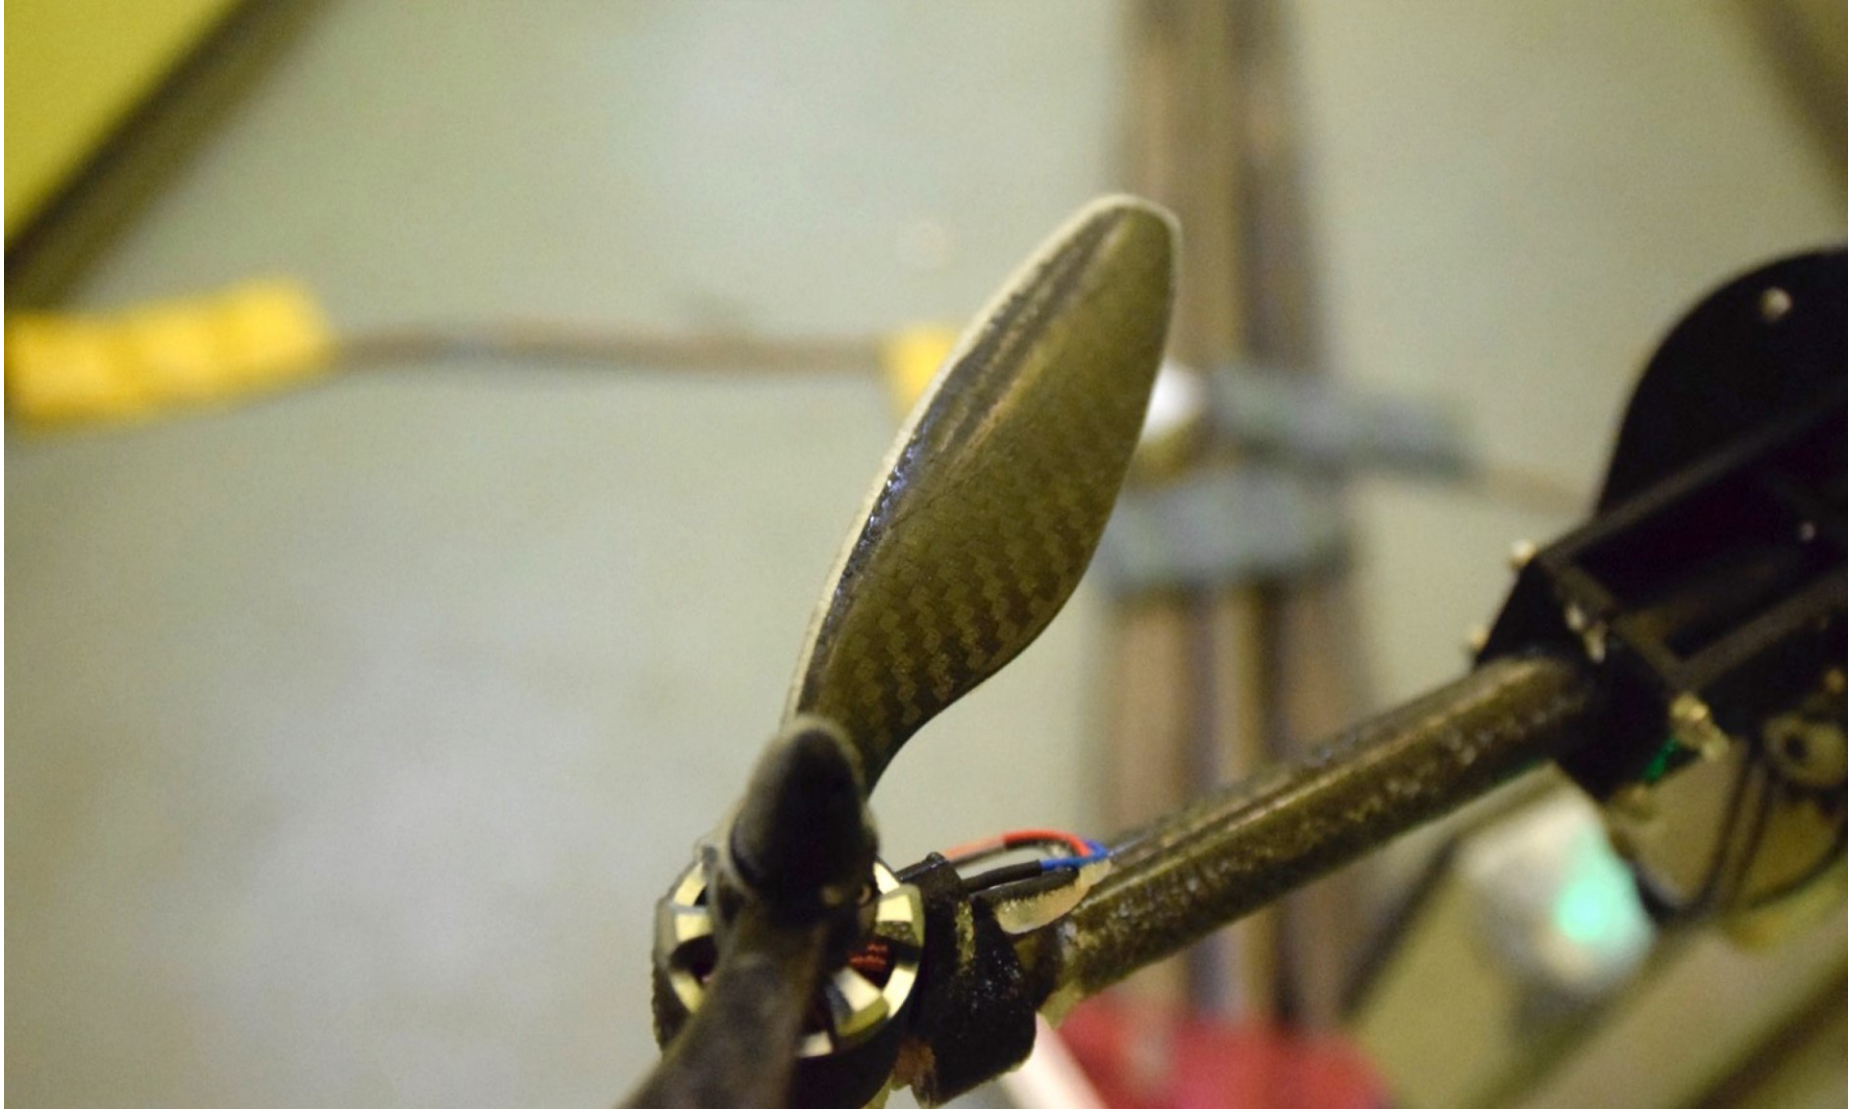
## Example Ice Amount 2 – Little ice (max. 2mm)
