# Project „SOPHIA“ - Final Report

(Study of Propeller Icing Hazard in Mini-UAV Aviation)

Meteomatics GmbH, St. Gallen 2017-05-01

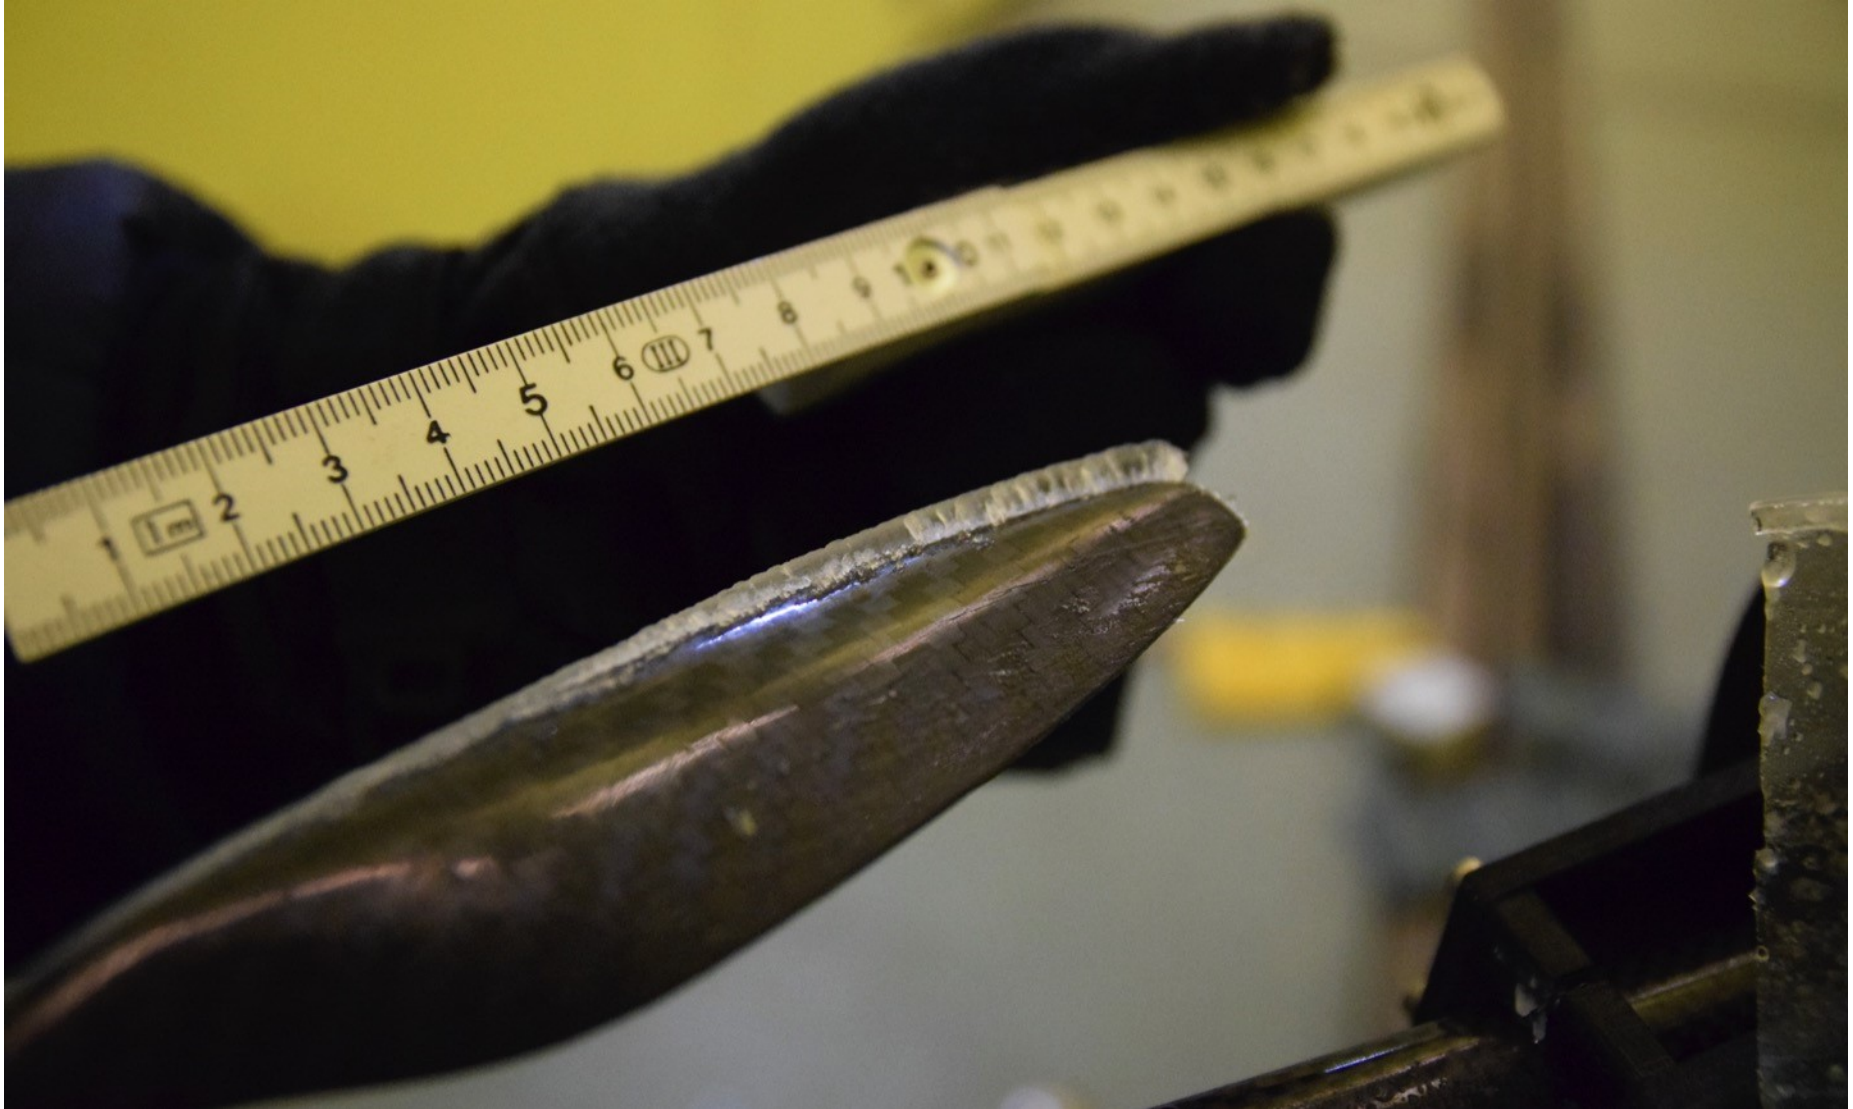
## Example Ice Amount 3 – Much ice (max. 4mm)

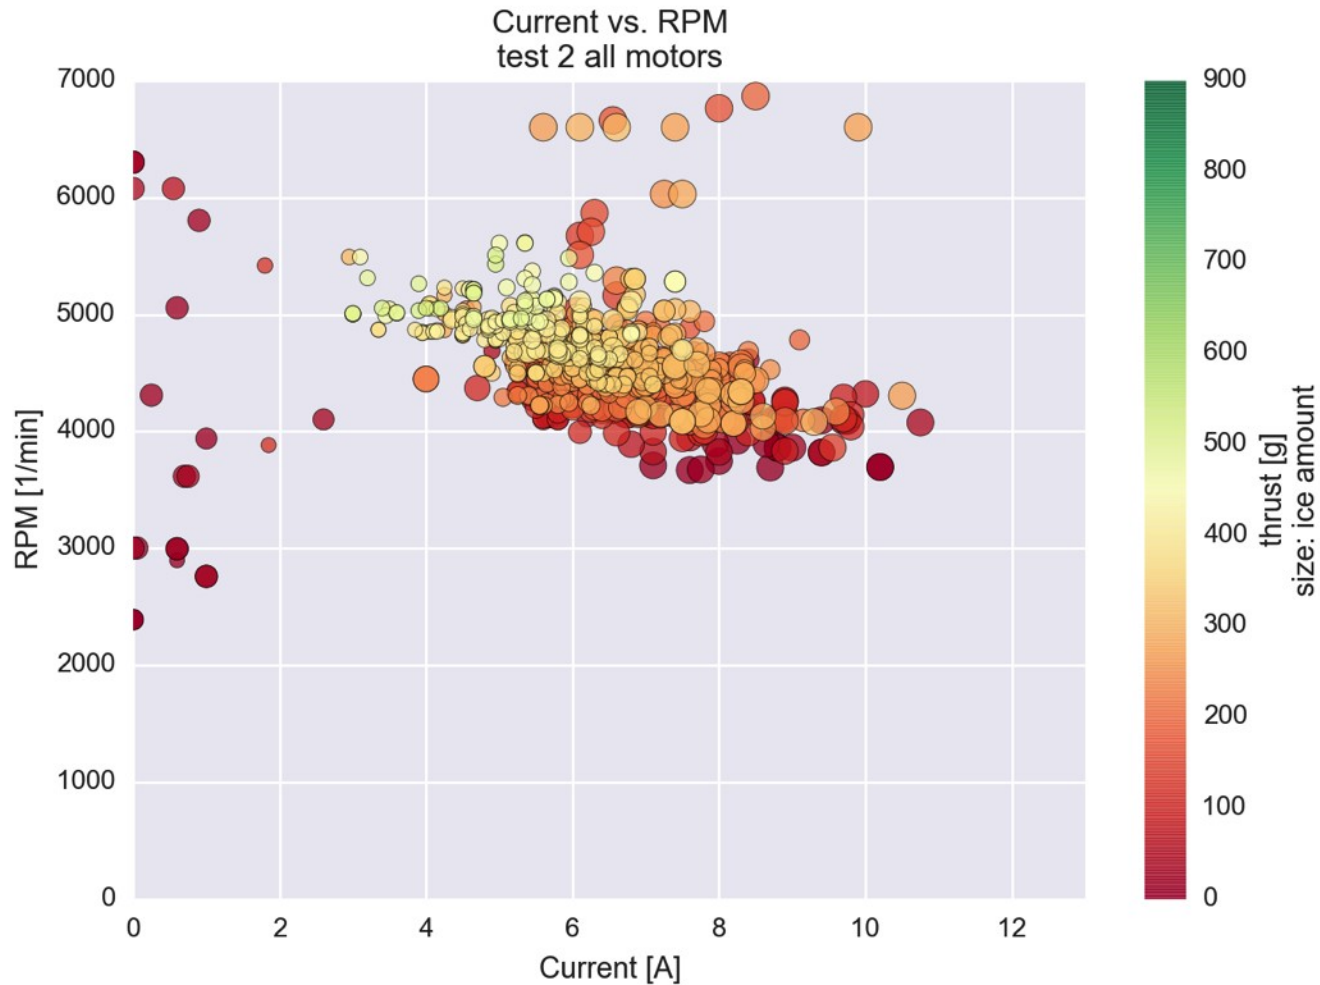
No.	Start	End	Temperature	LWC	MVD	Condition
2	13:12	13:31	-5 °C	0.5 g/m <sup>3</sup>	20 μm	Stratiform Cloud

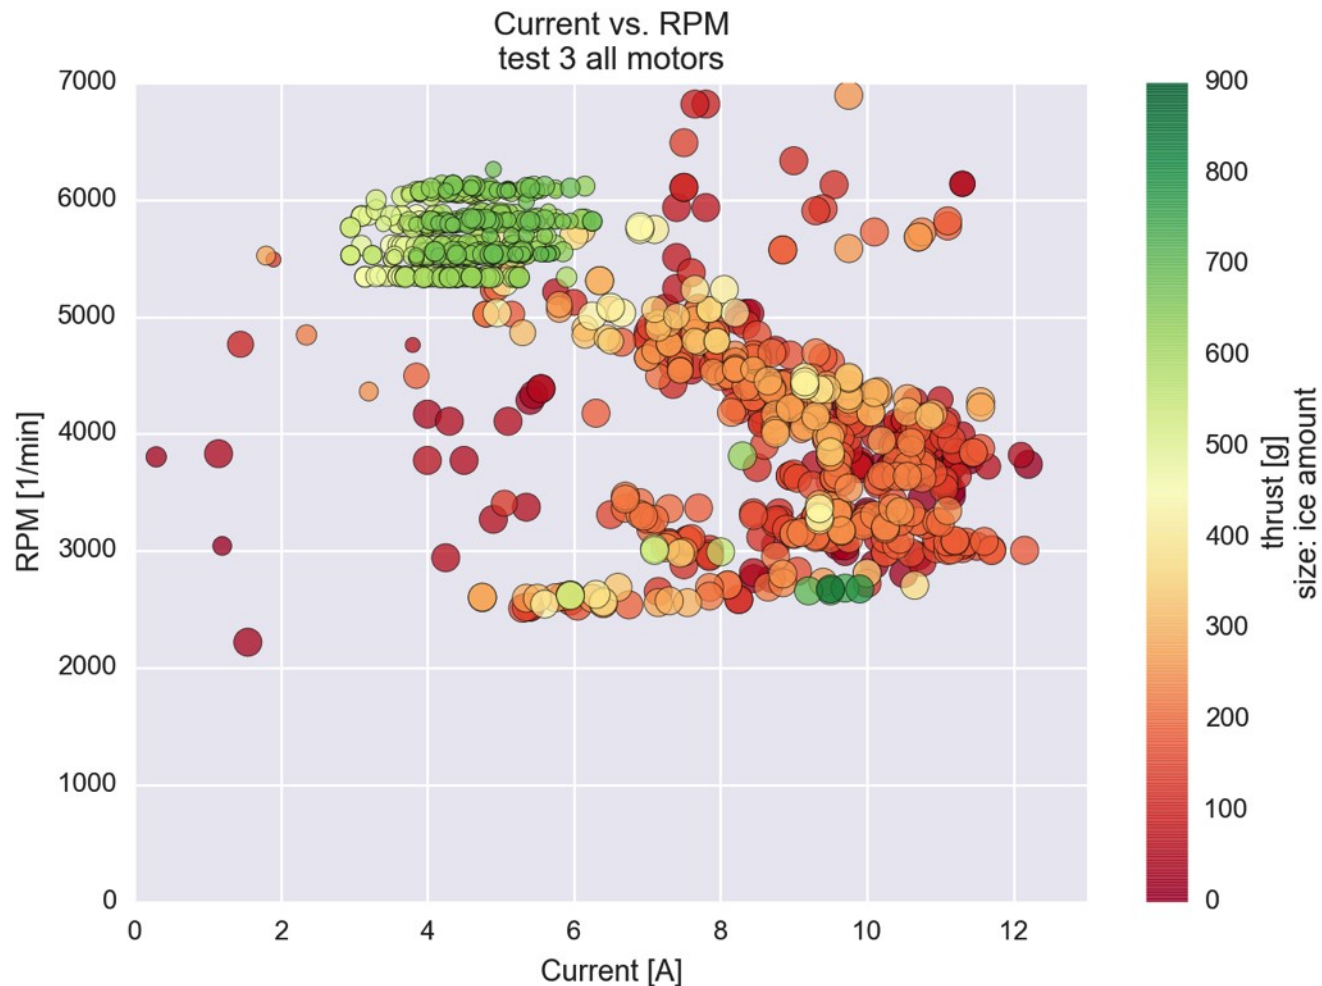
No.	Start	End	Temperature	LWC	MVD	Condition
3	13:45	14:19	-5 °C	1.25 g/m <sup>3</sup>	30 μm	Cumuliform Cloud

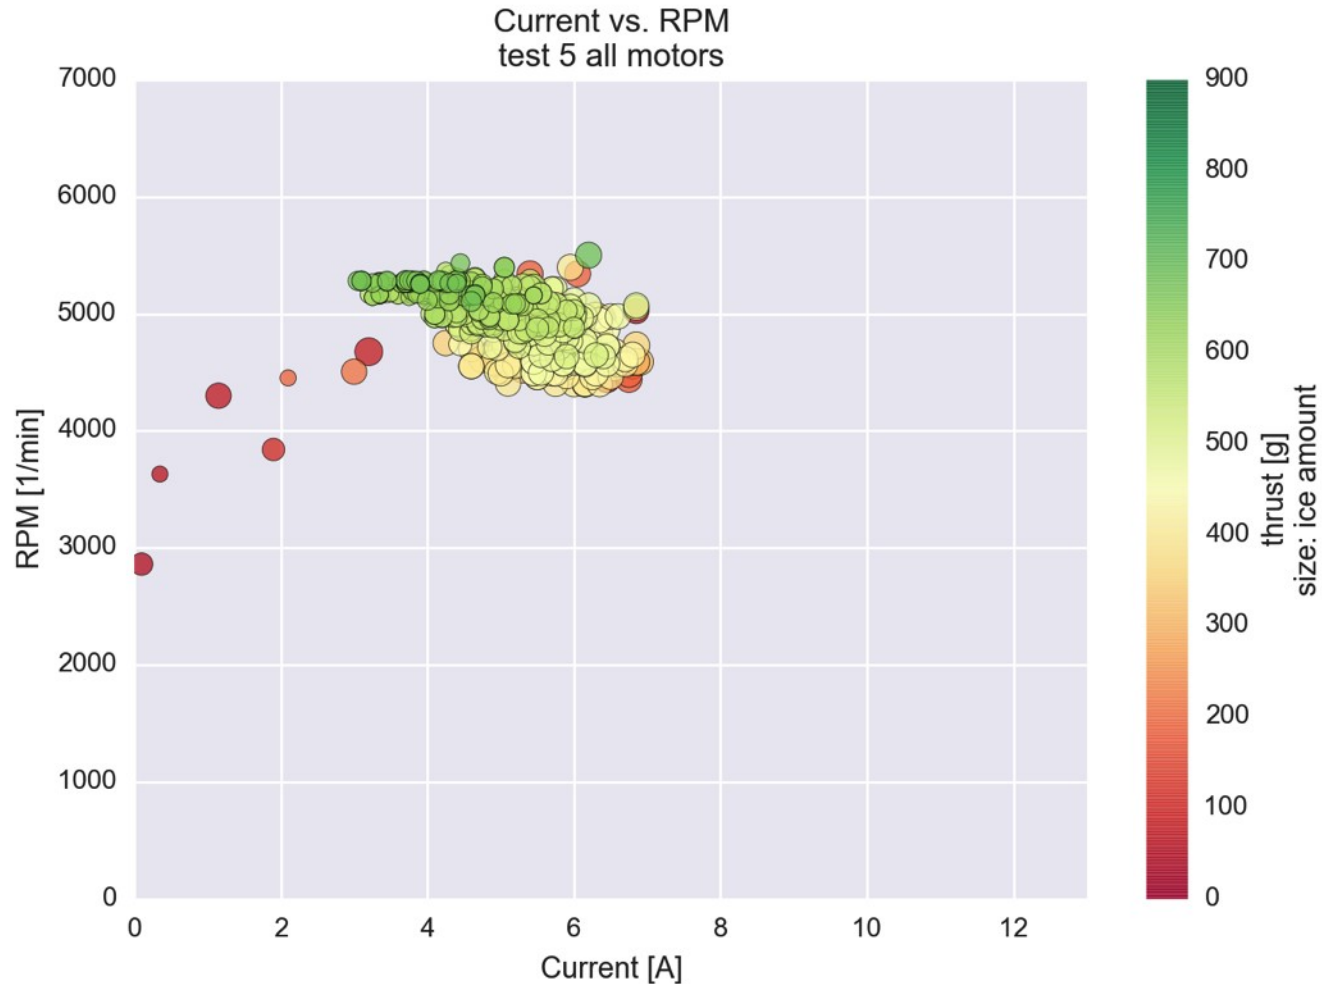
No.	Start	End	Temperature	LWC	MVD	Condition
5	17:10	17:26	-20 °C	0.7 g/m <sup>3</sup>	30 μm	Cumuliform Cloud

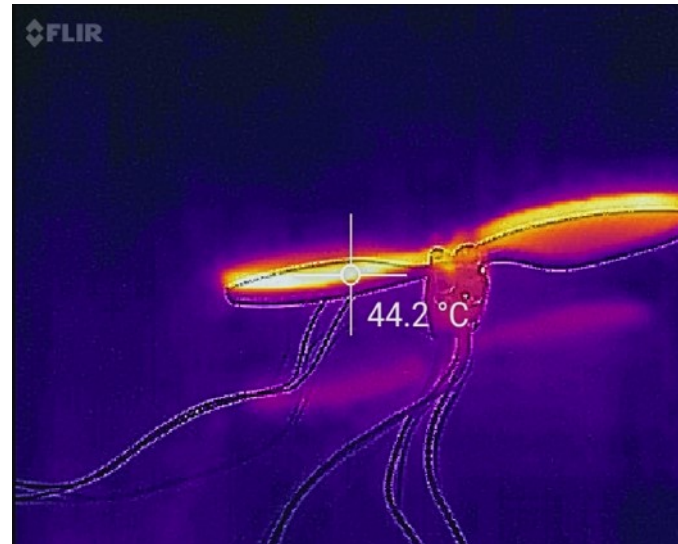
# IR Images from propeller heating\*

Experiment with single wire:

Distinct heating of the propeller was already achieved after a few seconds

- How to get electrical power into the propeller?
  - Conduction on rotating axis with a hollow shaft and brushes.
  - Development of an appropriate slip ring.
    - Problem: Normal slip rings cannot manage the high drive of the Meteodrone. → strong erosion
- How to heat the propeller in a uniformly distributed way?
  - Pullheim experiment
    - Two single-wire circles
  - More robust system is needed.
    - Solution: flexible foil
